# Disaster Recovery Project Sheet

Furniture Manufacturing

Warehouse Fire / heavy soot contamination and fire fighting water damage to machinery.

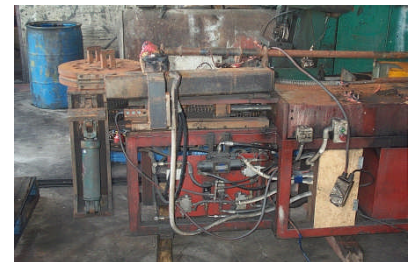
Pipe Bender BEFORE

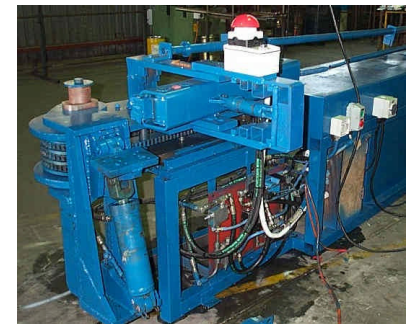
Pipe Bender AFTER

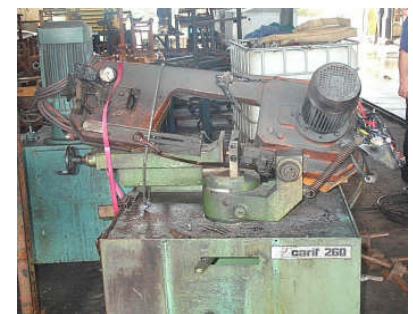
Band Saw BEFORE

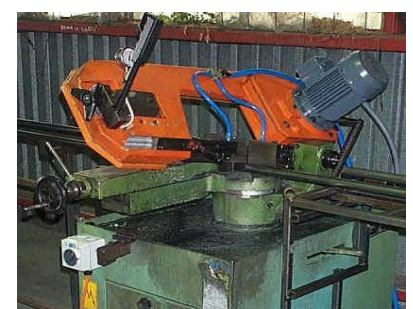
Band Saw AFTER
